1. Overview

Greenways Incorporated (GWI), EcoScience (a division of PBS&J), and PBS&J-Charlotte conducted an existing conditions evaluation in January 2009 of the proposed greenway corridor. Consultant staff walked the majority of the corridor, photo-documenting site features, taking notes, observing use and connections, walking existing trails and mapping specific areas using Global Positioning Systems (GPS). Sites of opportunities and constraints were mapped using Geographic Informational Systems (GIS). The examination and analysis of the corridor included both GIS mapping and fieldwork. A graphic presentation of these results is included in Chapter 3: Opportunities and Constraints.

9. Preliminary Evaluation of Possible Hydraulic Impacts of Pedestrian Bridge Locations along Bolin and Jones Creeks

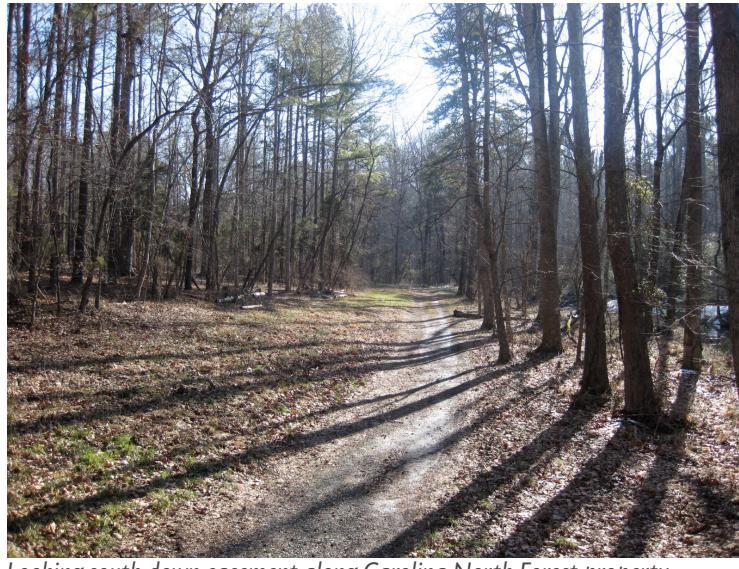
Looking south down easement along Carolina North Forest property.

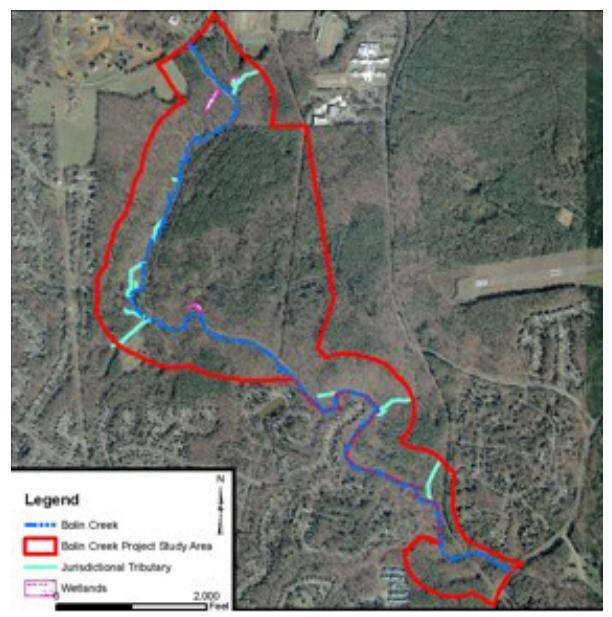
Section 404 Resources within the Bolin Creek PSA

A jurisdictional delineation was not performed as a part of this preliminary constraints evaluation. However, potential jurisdictional areas were documented during field investigations. Streams, wetlands, and waters of the U.S. were observed within the PSA. Town of Carrboro and NC Division of Water Quality (NCDWQ) staff walked the corridor from Estes Dr. to Homestead Rd. in October, 2009. NCDWQ staff intend to return to the area and provide jurisdictional determinations for stream features.

Prior to any construction activity, written justification for impacts and potential compensatory mitigation will be required for 404/401 permit issuance by the United States Army Corps of Engineers (USACE) and NCDWQ, respectively. A series of nationwide permits are available through the USACE for minor, specific activities. Nationwide Permit #42 (for Recreational Facilities) may be appropriate, along with the accompanying NCDWQ General Certification 3705. If less than 300 linear feet of stream and less than 0.5 acre of total wetlands and open waters are impacted due to proposed construction activities, a Nationwide Permit (NWP) may be issued by the USACE with an associated 401 Water Quality Certification issued by NCDWQ. Proposed impacts exceeding the above-mentioned thresholds will likely require an Individual Permit (IP).

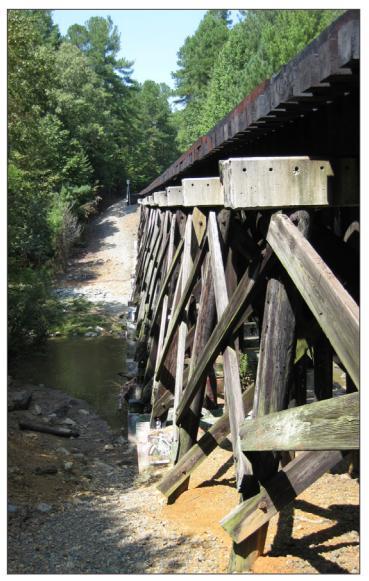
Railroad overpass at Estes Dr.

Railroad routes adjacent to or intersecting a trail present a significant situation within trail development. The rights-of-way associated with rail lines are typically very wide and their owners fear the liability associated with public access. The proposed Bolin Creek trail will encounter the Norfolk Southern rail line, which parallels and then traverses the southern portion of the corridor. Depending on final trail alignment, negotiations will need to be made with Norfolk Southern as to the degree of public access allowed within their right-of-way.

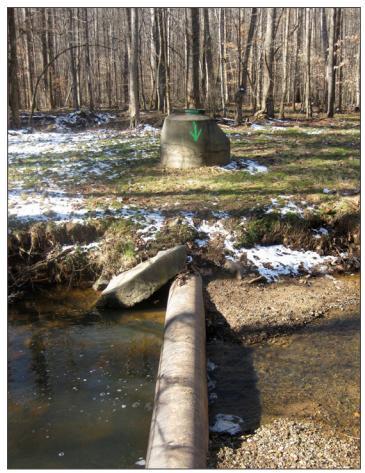
Typical sewer trunk line along Bolin Creek

The Orange County Water and Sewer Authority (OWASA) sewer easement makes up a large portion of the corridor offering open cleared areas suitable for trail development. Sewer trunk lines traverse the corridor in some areas near the Bolin Forest and Spring Valley neighborhoods, as well as Carolina North Forest. If utilized for trail routing, these easements will require negotiations with OWASA with respect to their facilities.

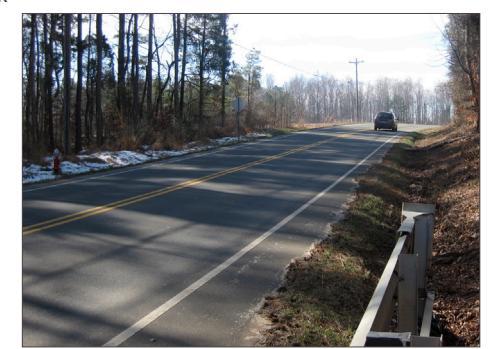
• *Homestead Road* -High motor vehicle speeds (frequently over 40 miles per hour), and two lanes of traffic make up this roadway which connects northern Carrboro to western Chapel Hill. Poor site lines at grade make a crossing unlikely. Below-grade conditions present feasibility for a trail underpass with ample vertical clearance.

Homestead Rd. at grade.

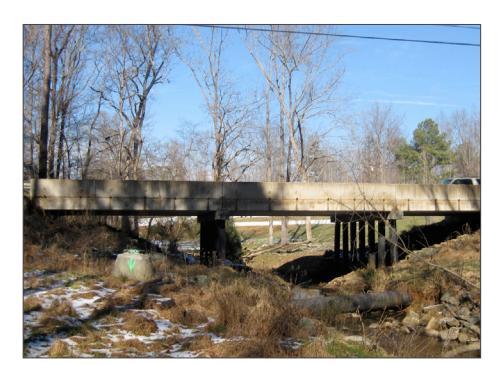
Bridge at Homestead Rd.

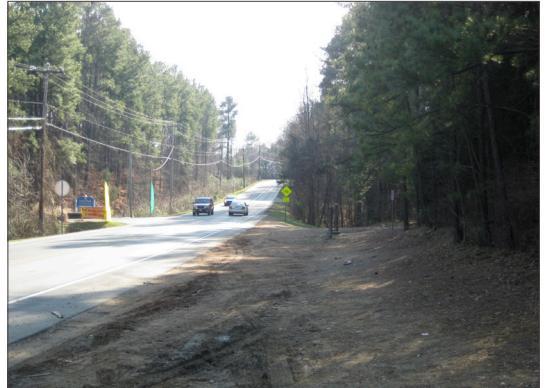
• *Estes Drive Extension* - A highly trafficked, north-south thoroughfare connecting Chapel Hill to Carrboro. Roadway crossing is approximately 30-feet above Bolin Creek with 3:1 slopes presenting a topographical challenge for at-grade crossing conditions. Poor site lines at north and south ends present dangerous at-grade crossing conditions.

Estes Dr. at grade.

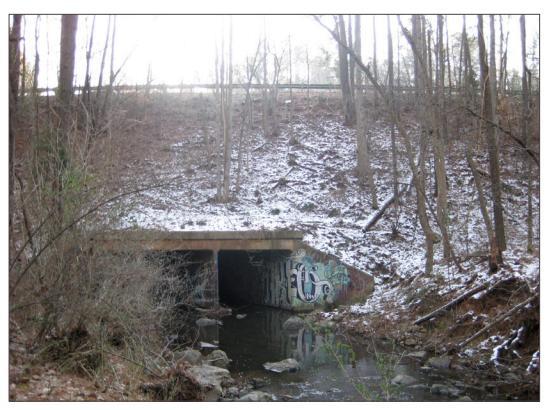
The box culvert beneath Estes Dr. extension.

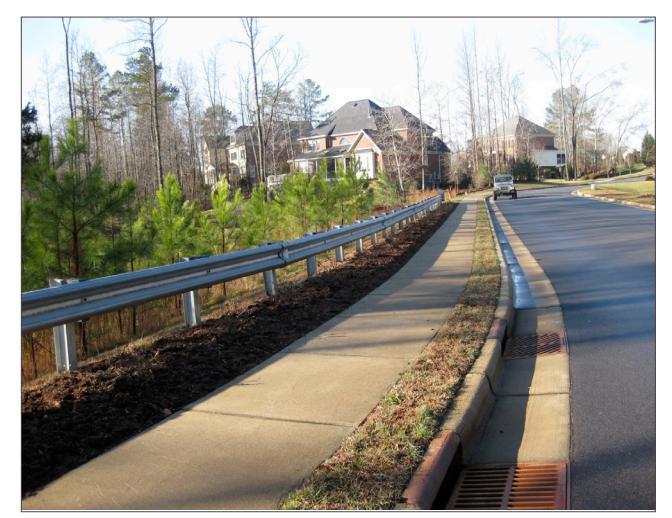
• *Turtleback Crossing* -A residential connector, this roadway is two lanes and has a speed limit of 25 miles per hour. At-grade crossings are more feasible at this location because site lines are open and topography surrounding the roadway crossing is suitable for trail development.

Turtleback Crossing at grade.

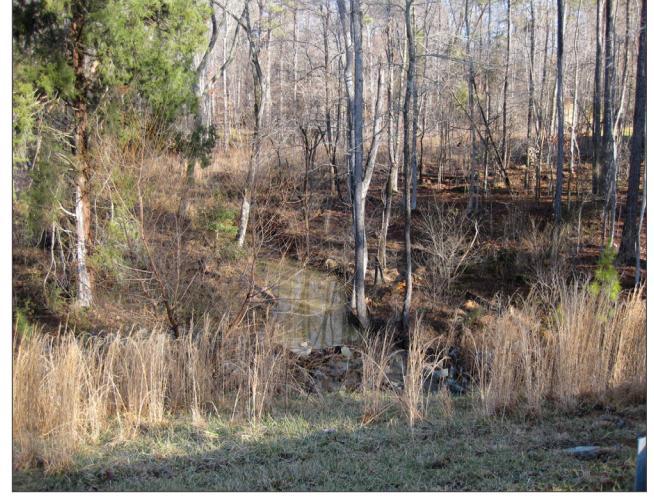
Creek crossing conditions beneath Turtleback Crossing.

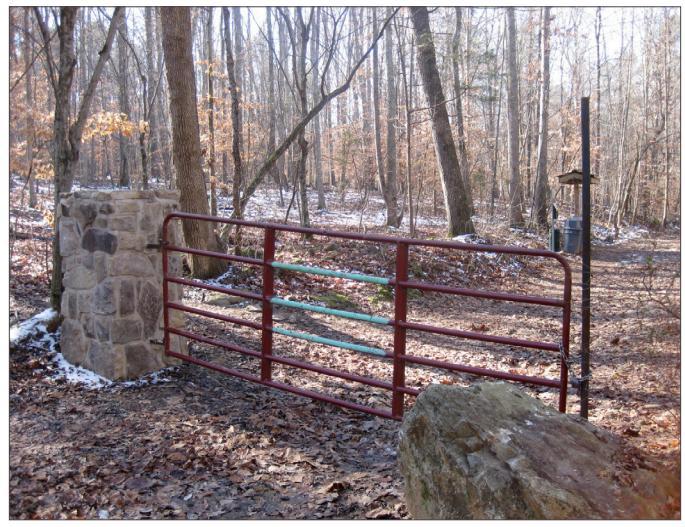
Trail conditions behind Chapel Hill-Carrboro schools.

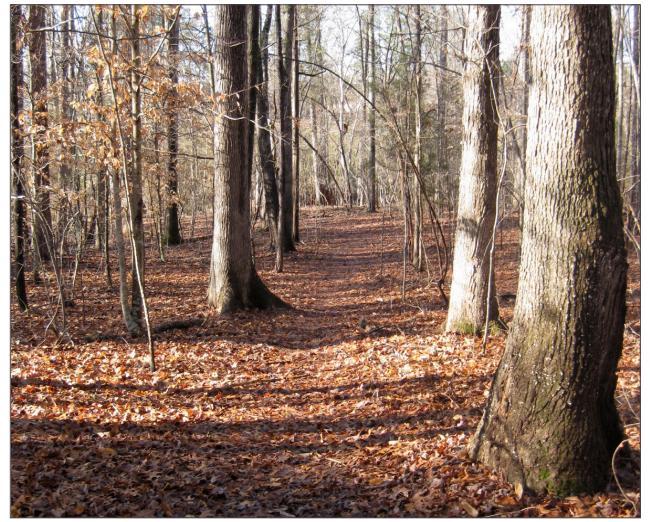
Foot trails behind Tallyho Trail.

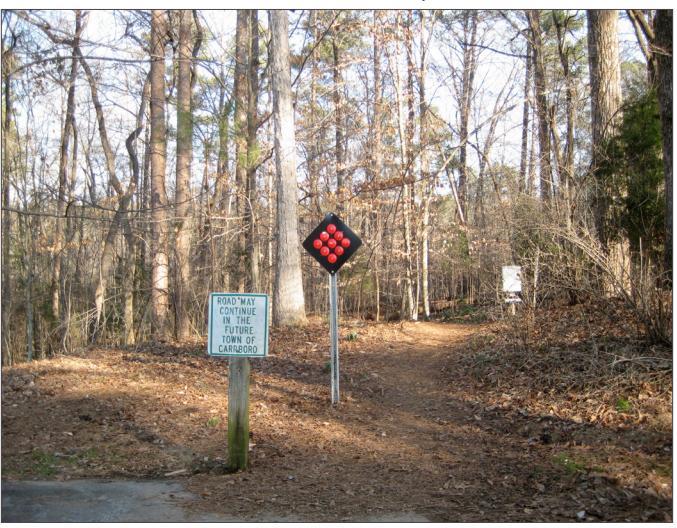
Foot trails leading down to Bolin Creek from Wild Oak Dr.

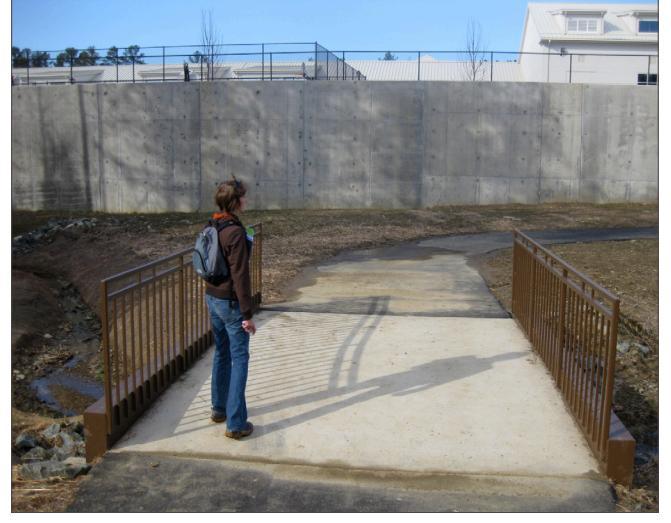
Paved trail behind Morris Grove Elementary School.

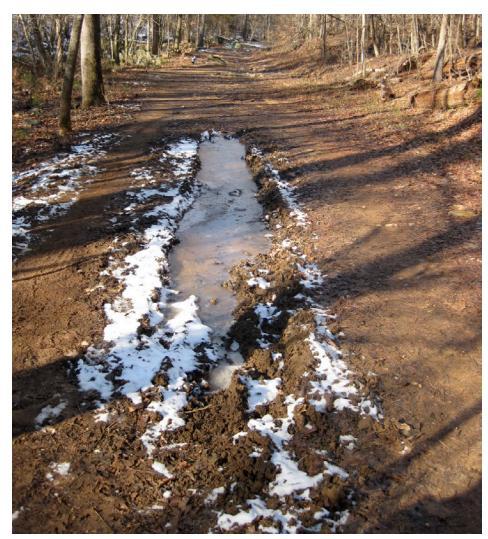
continuous high use, widens the area of disturbance over time. The agitated suface conditions created by foot and bike traffic lead to increased erosion and sedimentation along the corridor, which has the potential to impact water quality during storm events.

Maintenance vehicles and overuse have contributed to erosion along the corridor.

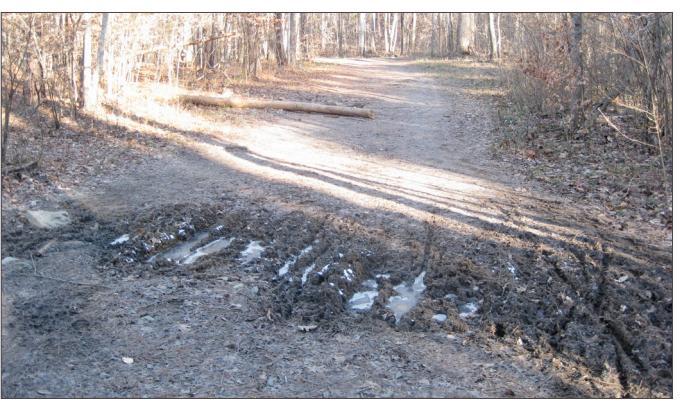
Visible signs of overuse along Bolin Creek.

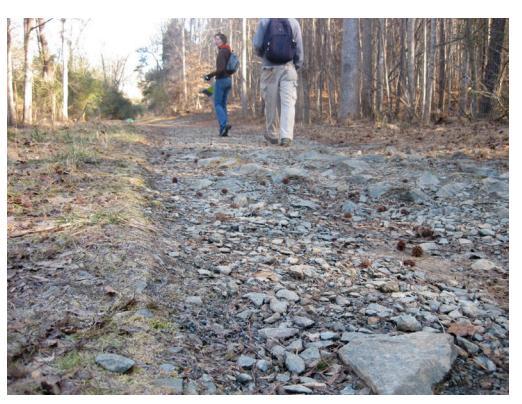
Hardscape materials imported onsite have furthered erosion problems.

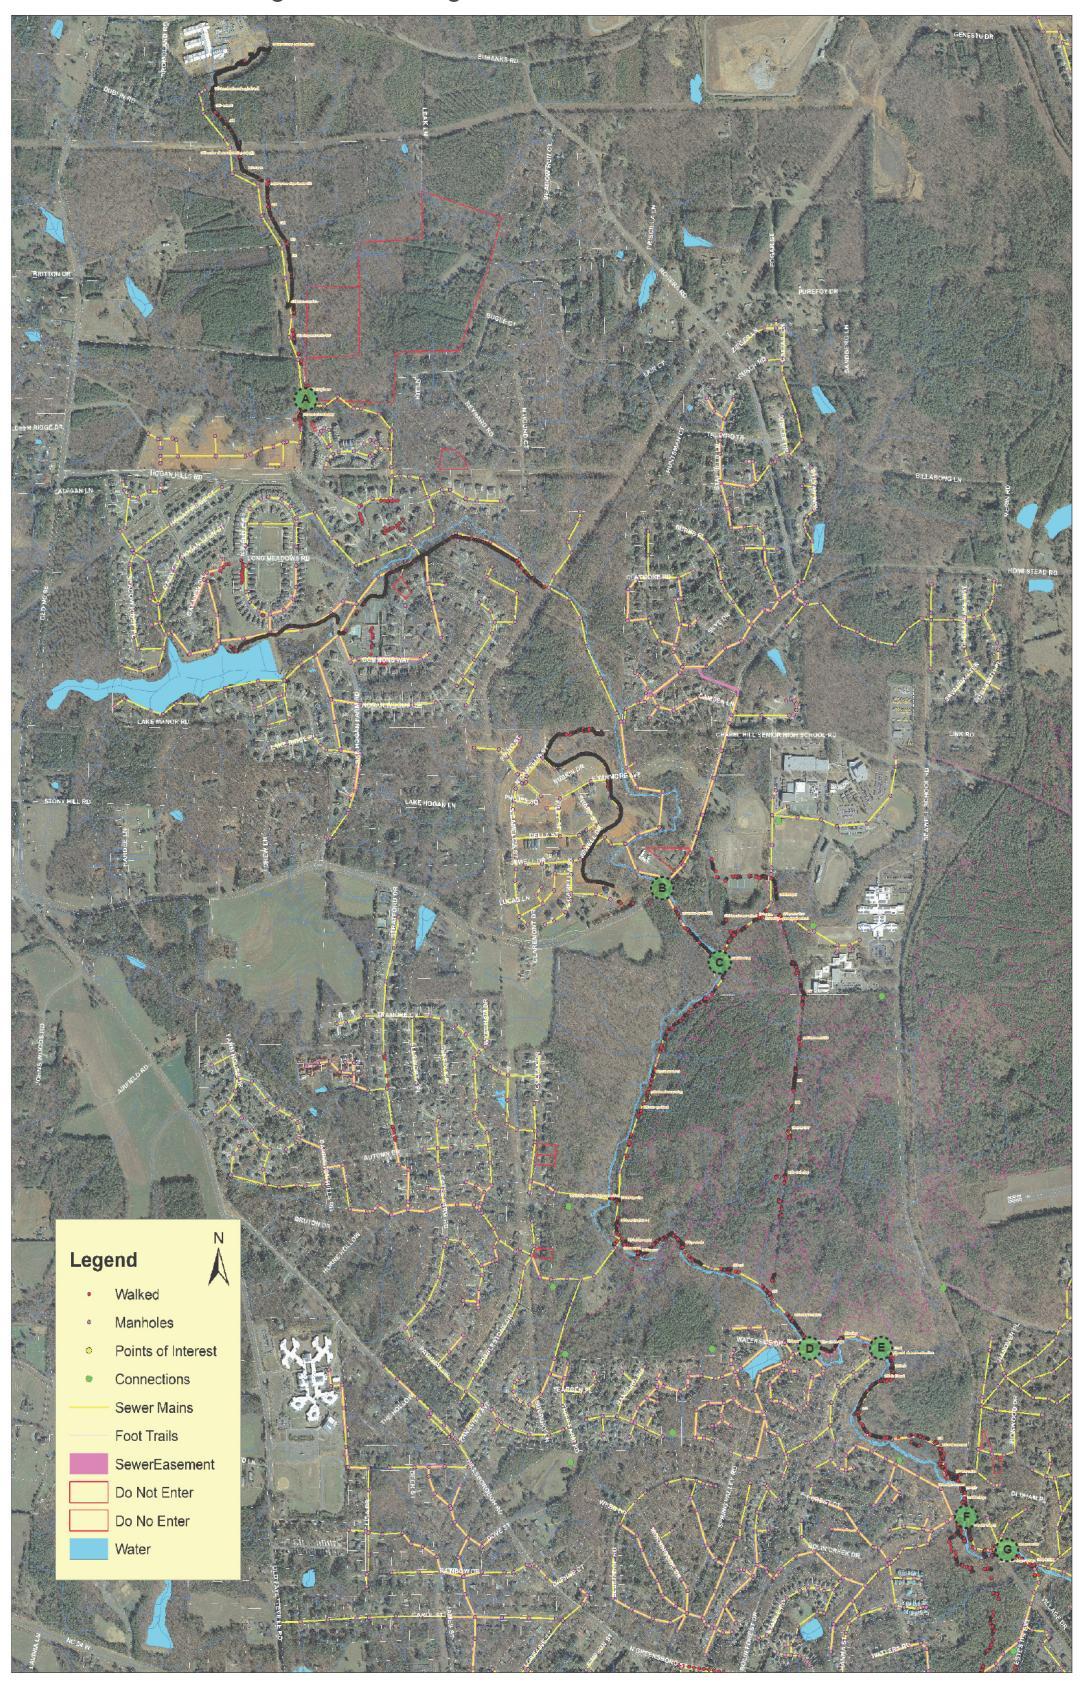
Evaluated Pedestrian Bridge Locations along Bolin and Jones Creek

The following paragraphs will address each potential crossing site individually and correspond to the locations shown on the included exhibits. An overall map is shown with each location on the next page.

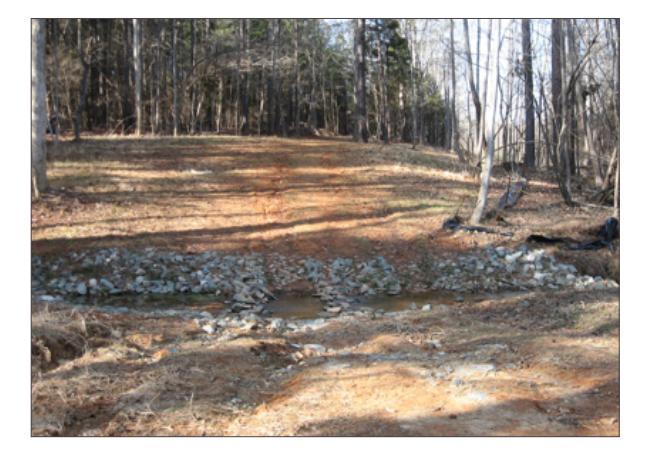
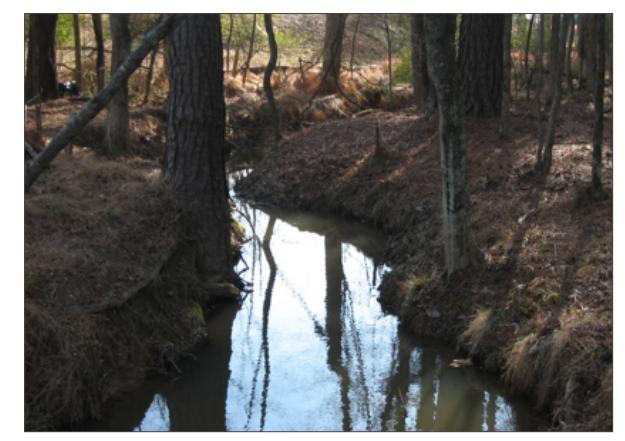
A. Buckhorn Branch Crossing

This site is located on Buckhorn Branch (tributary to Jones Creek) and currently has rip-rap lined banks with additional rock in channel to facilitate the crossing of vehicles to gain access to a sanitary sewer easement. The channel's confluence with Jones Creek occurs immediately downstream. This site is presently located within the SFHA (~ 120 ft wide) and stream buffer, appears to be contained within a non-encroachment area (~ 40 ft), and experiences a 100-year flood discharge of approximately 450 cubic feet per second (cfs). PBS@rJ recommends the implementation of a low-flow, curbed concrete bridge connecting the stream banks of Buckhorn Branch, which would permit the greenway to utilize the existing sanitary sewer easement northward.

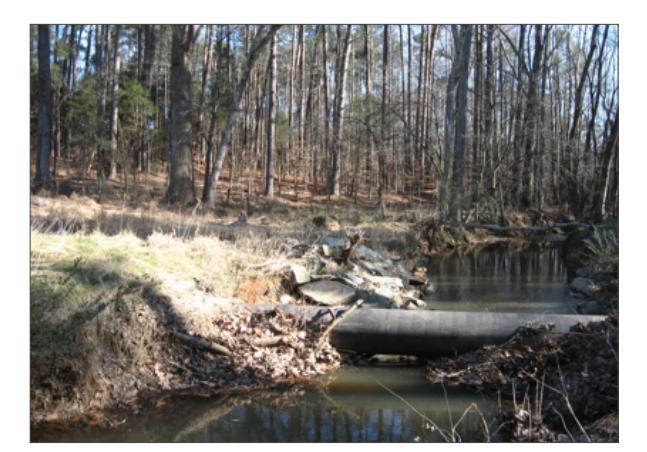
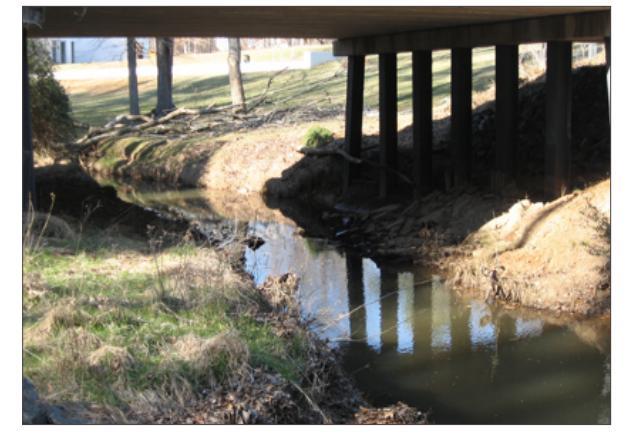
B. Homestead Roadway Bridge

This site is located on Bolin Creek at the Homestead Road Bridge with a large sanitary sewer ductile iron pipe (SSDIP) crossing immediately downstream of the bridge. This site is presently located within the SFHA (~ 130 ft wide) and stream buffer, is contained within a floodway (~ 60 ft), and experiences a 100-year flood discharge of approximately 2,790 cfs. PBS&J recommends utilizing the existing sanitary sewer easement along the west bank of Bolin Creek as the proposed greenway alignment and excavating the west bank underneath the bridge to establish an underpass for pedestrian access north and south of Homestead Road.

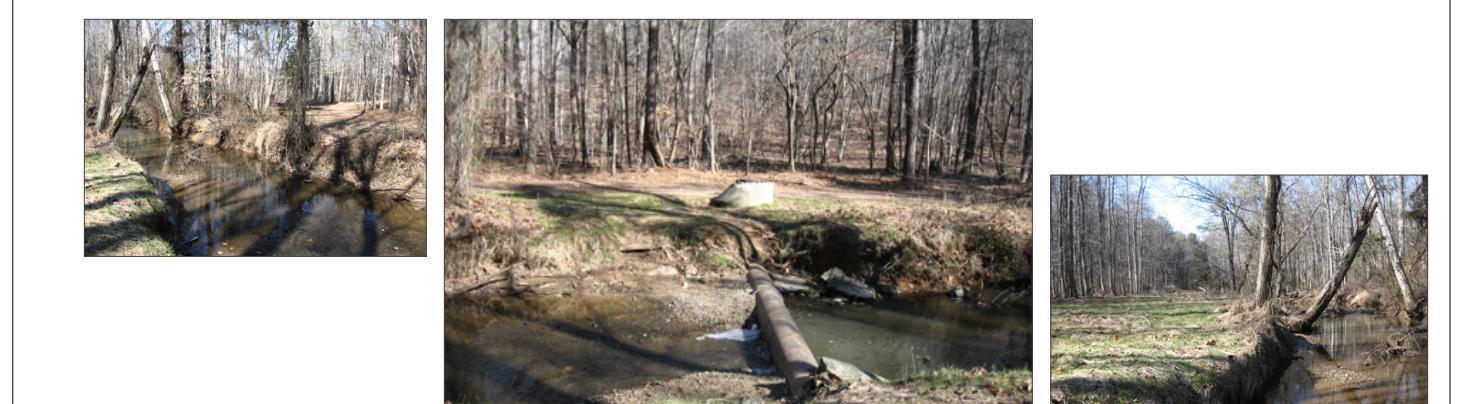
C. Crossing south of Homestead Roadway Bridge

This site is located on Bolin Creek at a SSDIP crossing and is presently located within the SFHA (~ 600 ft wide) and stream buffer, is contained within a floodway (~ 400 ft), and experiences a 100-year flood discharge of approximately 2,790 cfs. PBS&J recommends the implementation of an arched wooden bridge with guardrails that will connect the existing SS easement paralleling the east and west stream banks in such a way that will not hinder access to the SS-DIP and its two associated manholes. Town staff, Sungate Engineering, and GWI visited this site after the initial field investigation, resulting in a recommendation to relocate the crossing upstream to minimize flood zone impacts.

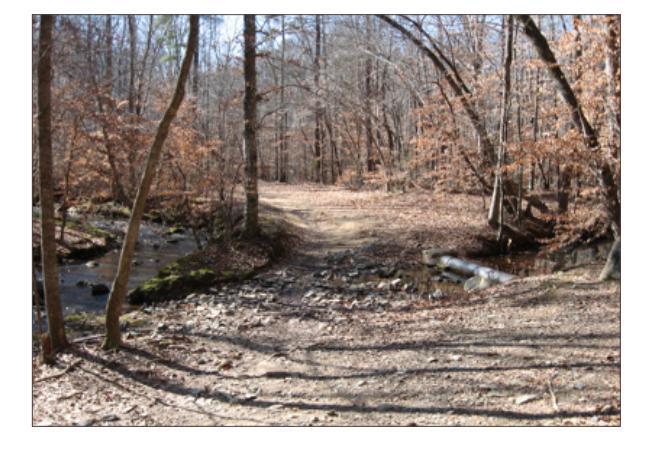
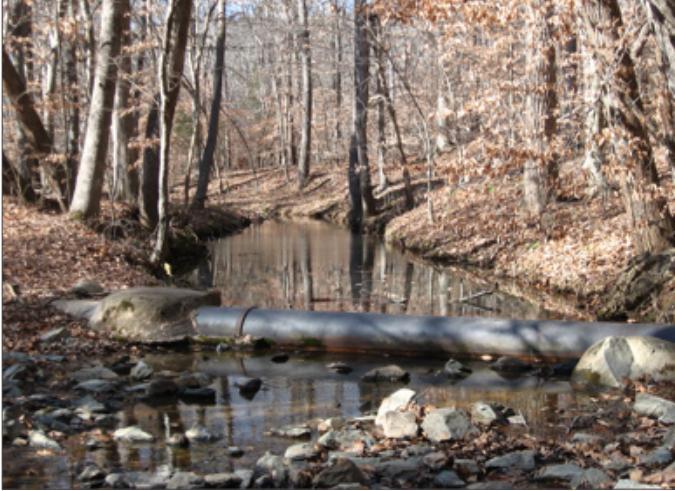
D. Crossing at Spring Valley Subdivision

This site is located at the confluence of Bolin Creek and a tributary near a SSDIP crossing east of Spring Valley subdivision. This site is presently located within the SFHA (~ 240 ft wide) and stream buffer, is contained within a floodway (~ 90 ft), and experiences a 100-year flood discharge of approximately 3,600 cfs. A three-foot wide wooden footbridge currently provides access from the playground (west bank) to the existing SS easement on the east side of Bolin Creek. PBS&J recommends the implementation of a low-flow, curbed concrete bridge over the tributary immediately downstream of the SSDIP crossing and an arched wooden bridge with guardrails over Bolin Creek in vicinity of the existing footbridge to provide access from the playground.

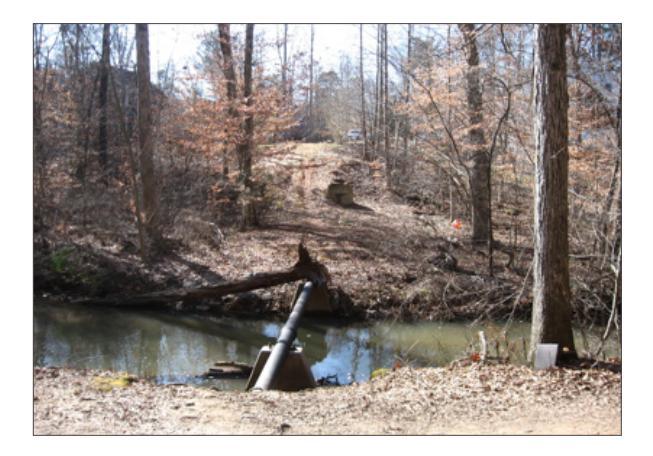
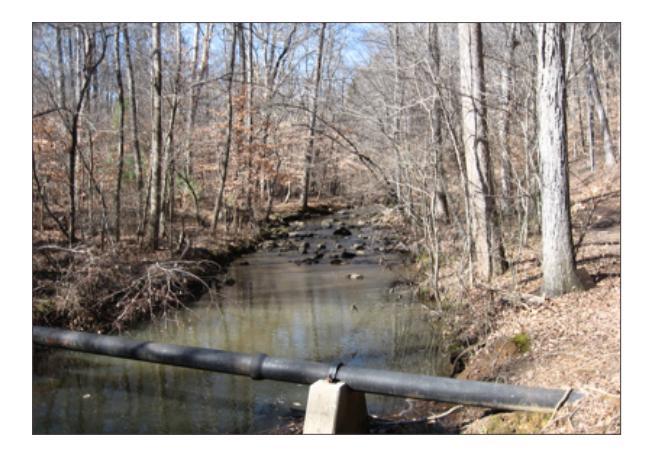
E. Pathway Dr. Crossing

This site is located on Bolin Creek at a SSDIP crossing. This crossing area is accessed at the end of Pathway Dr. and represents an important potential pedestrian connection to Bolin Forest. The site is presently located within the SFHA (~ 140 ft wide) and stream buffer, is contained within a floodway (~ 110 ft), and experiences a 100-year flood discharge of approximately 3,600 cfs. One SS easement parallels the east bank, while another is perpendicular to the west bank. PBS&J recommends the implementation of an arched wooden bridge with guardrails over or adjacent to the SSDIP crossing.

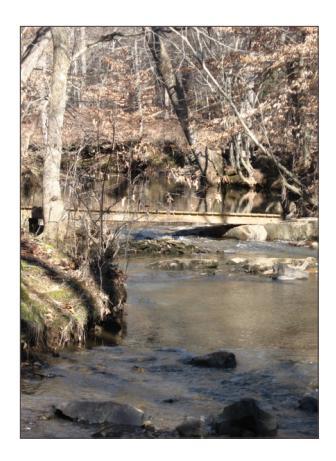
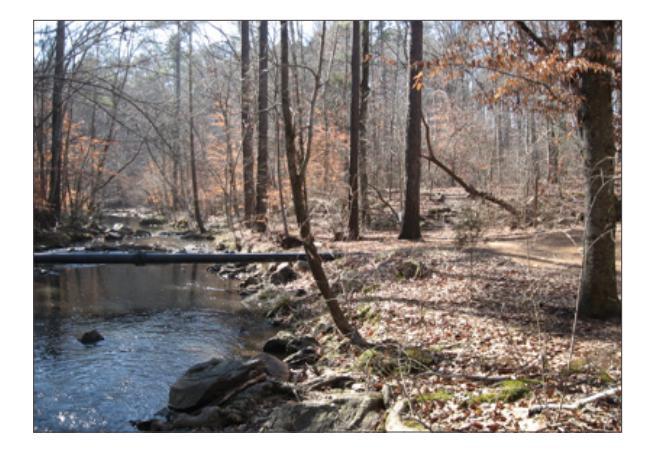
F. Crossing at Bolin Forest Subdivision

This site is located on Bolin Creek at a SSDIP crossing east of Bolin Forest subdivision. This site is presently located within the SFHA (~ 55 ft wide) and stream buffer, contained within a floodway (~ 45 ft) and experiences a 100-year flood discharge of approximately 4,100 cfs. A three-foot wide wooden footbridge provides access between the playground and walking trail on the west to the existing SS easement on the east side of the creek. PBScJ recommends replacing the existing footbridge with an arched wooden bridge with guardrails.

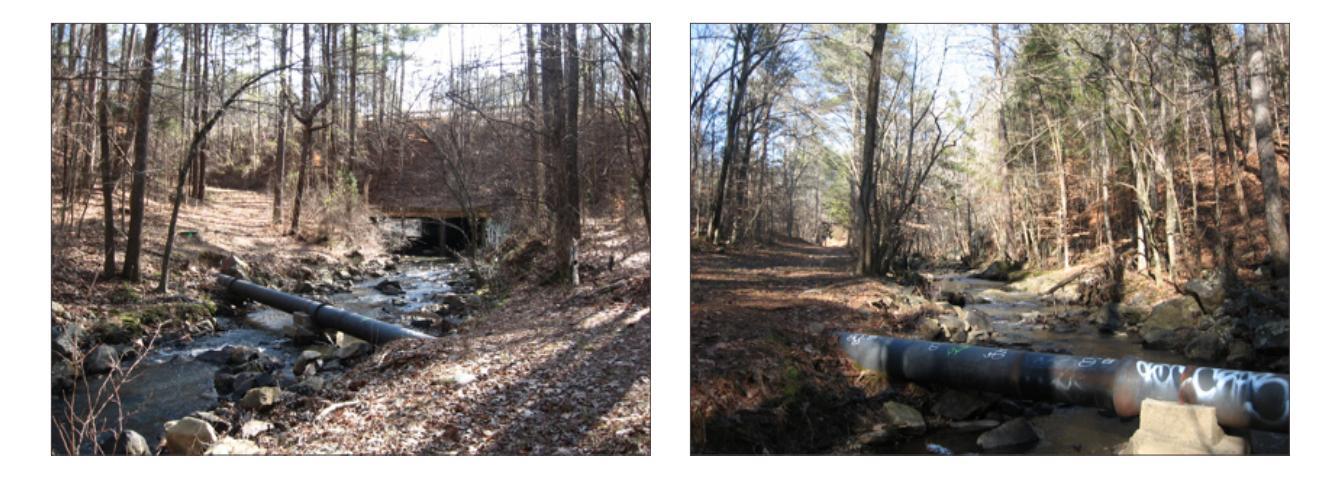
G. Crossing near Estes Dr. Ext.

This site is located on Bolin Creek in between an upstream SSDIP crossing and triple box culvert at Estes Drive Extension. This site is presently located within the SFHA (~ 200 ft wide) and stream buffer, is contained within a floodway (~ 40 ft), and experiences a 100-year flood discharge of approximately 4,400 cfs. A SS easement exists along the west side of the creek and connects to another SS easement at the DIP crossing. At this crossing, both easements veer away from the creek towards Estes Drive Extension.
